Green Infrastructure Research: Permeable Pavement at EPA's Edison Environmental Center

Background

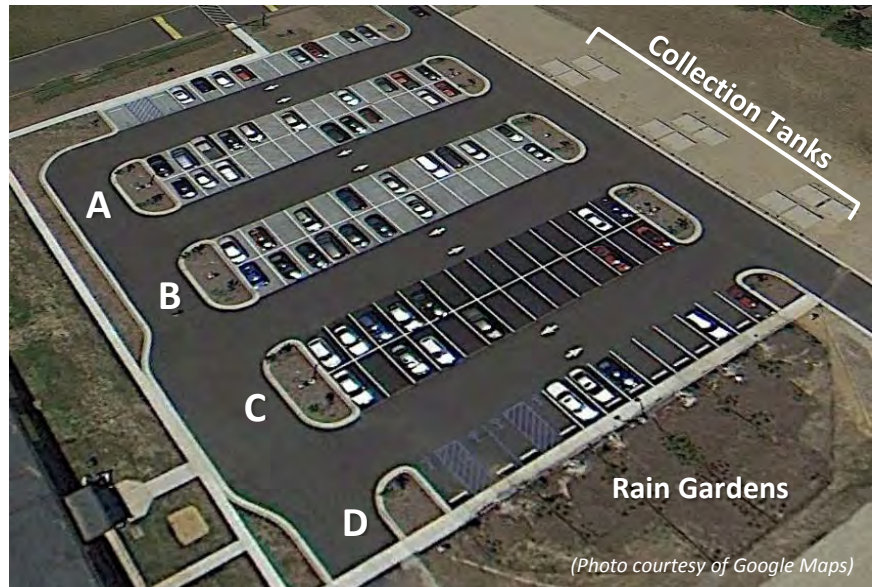
Figure 1. Aerial view of EPA's Edison Environmental Center permeable parking lot: (A) permeable interlocking concrete pavers, (B) pervious concrete, (C) porous asphalt, (D) conventional asphalt.

staff and visitors. The 43,000 sq. ft. parking lot has three types of permeable surfaces across 110 stalls in five rows (Figure 1). Figure 2 summarizes the lot's key features.
